Seat Base Swivel Troubleshooting Guide (All models)

Issue: Swivel tight to turn once installed into vehicle.

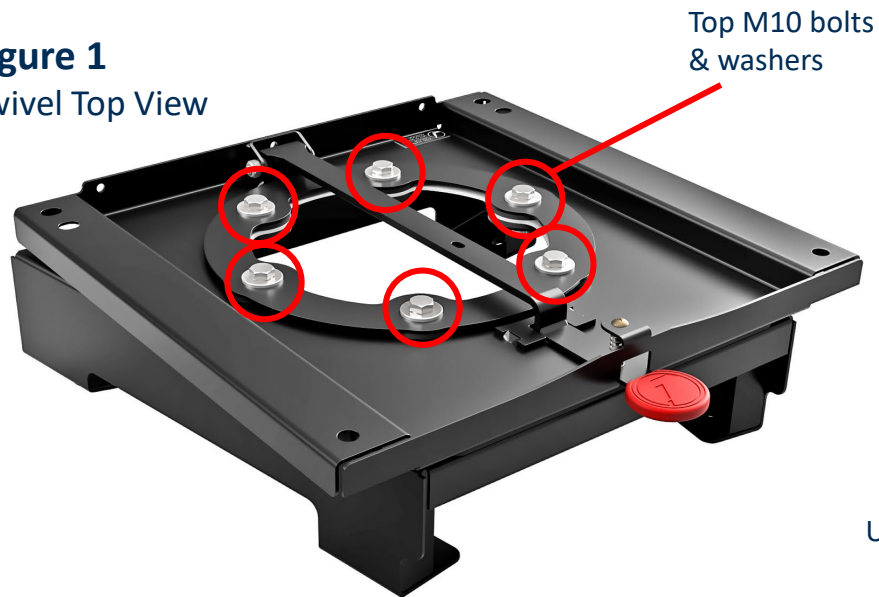
Figure 1
Swivel Top View

Cause: If the swivel is hard to turn once installed into the vehicle, it is most likely because the 6 main **M10 centre bolts** that hold the swivel together (**Fig. 1 & Fig. 2**) have been overtightened during the initial assembly or installation processes.

Solution: Loosen the **6 x M10 bolts/nyloc nuts**, ensure the swivel turns freely, then retighten them to **4.5Nm**. If a torque wrench isn't available, tighten the **nyloc nuts** just enough until all **12 washers** (6 x top and 6 x bottom) don't have any movement.

Note: *The seat may need to be removed from the swivel to allow access to the bolts/nuts.*
